# **CASTING BASIN GATE MAINTENTANCE RECORDS**

CYCLE 6

# Kiewit-General Inspection Report

**PROJECT:** SR 520 PONTOONS

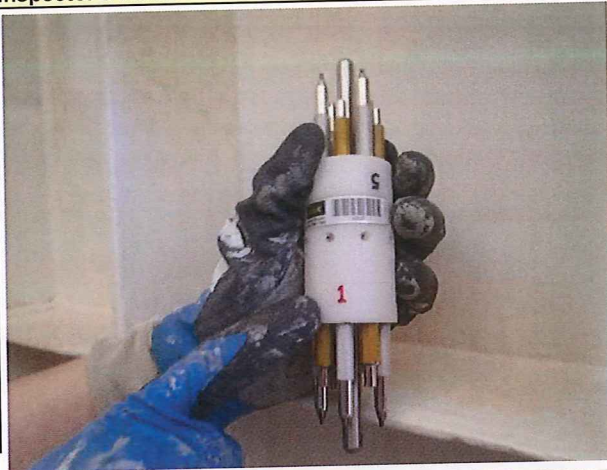
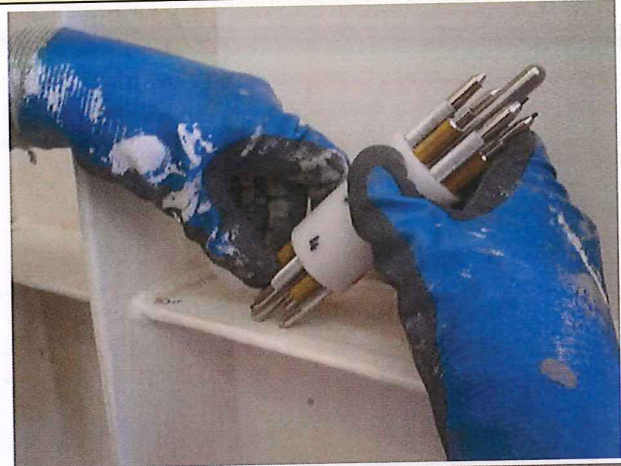
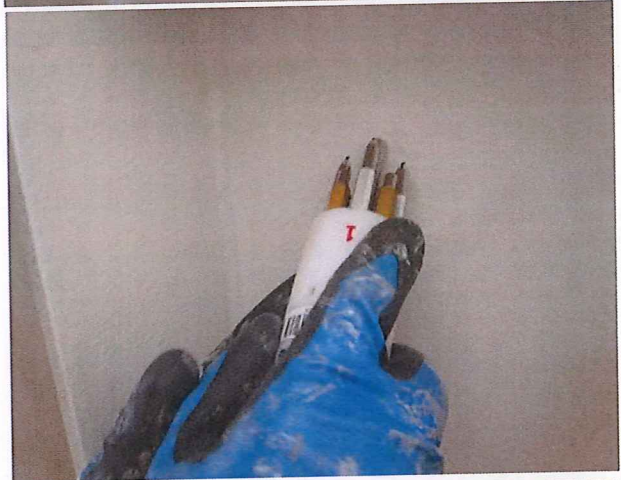
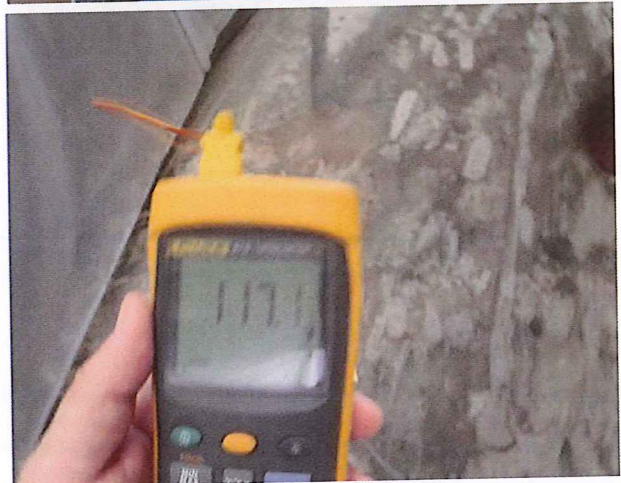
TOP SIX: Trusses 2/3 pencil hardness testing, T2/3 tent temperature readings

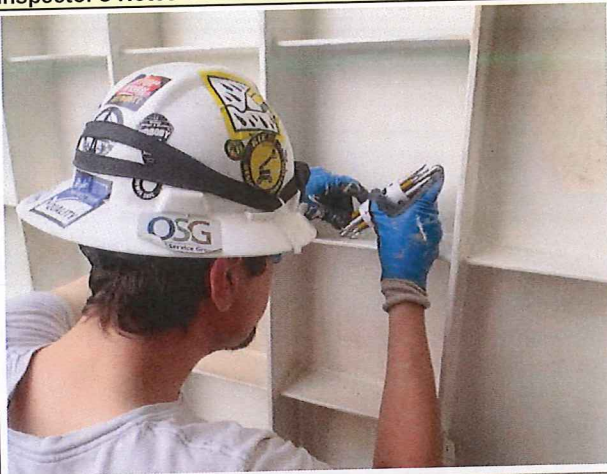
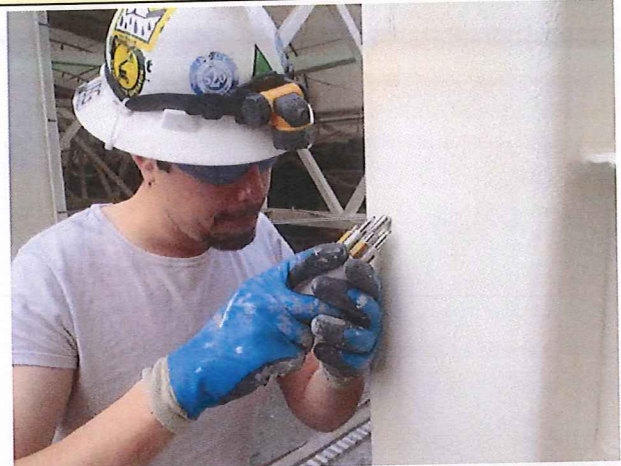
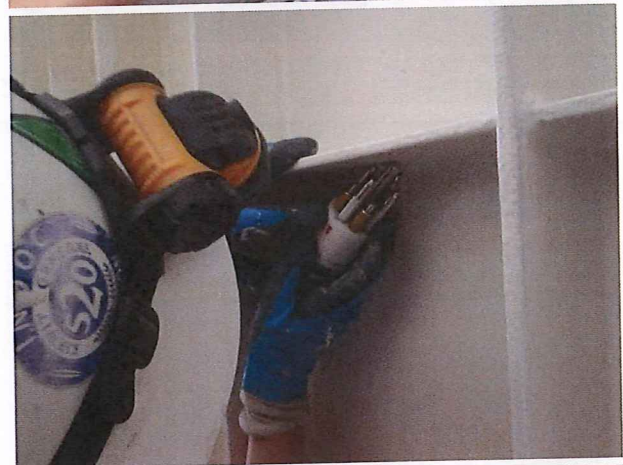
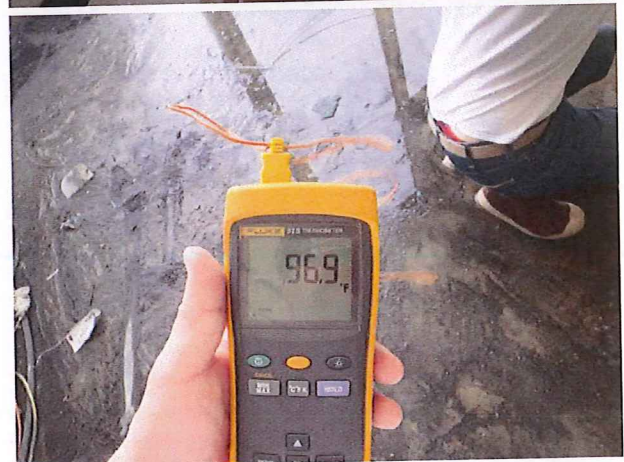
TOP SIX: Trusses 2/3 pencil hardness testing, T2/3 tent temperature readings

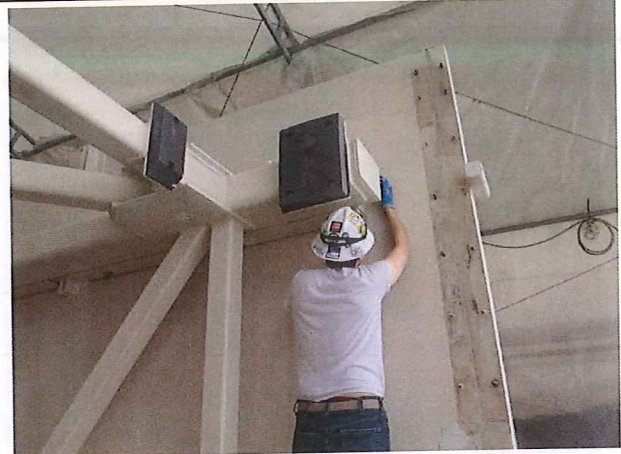
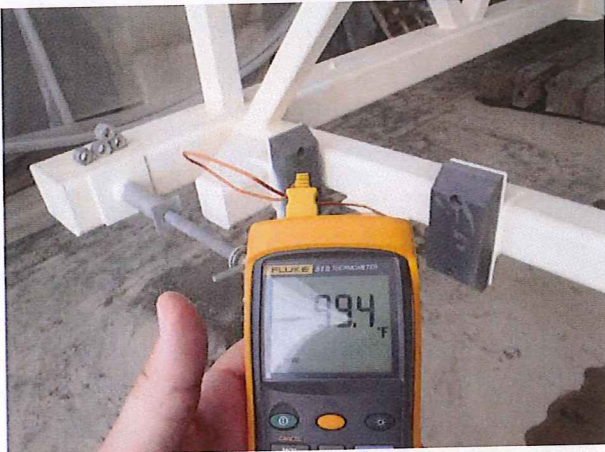
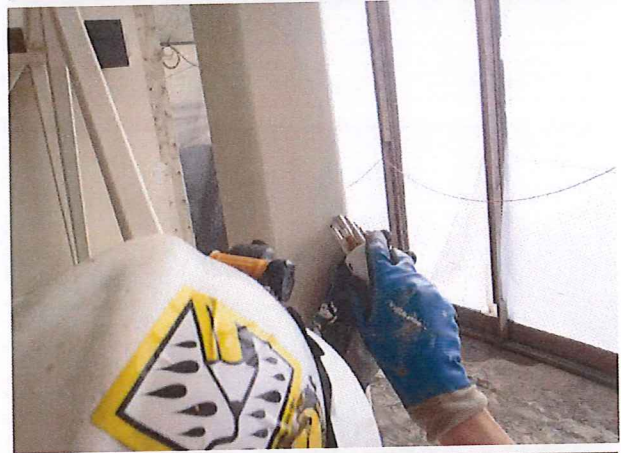
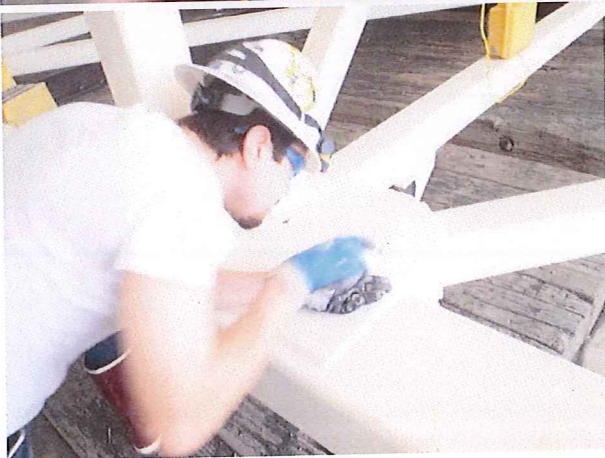
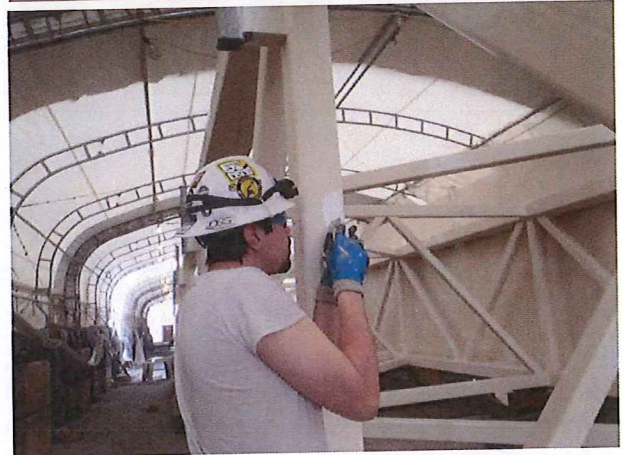
TOP SIX: Trusses 2/3 pencil hardness testing, T2/3 tent temperature readings

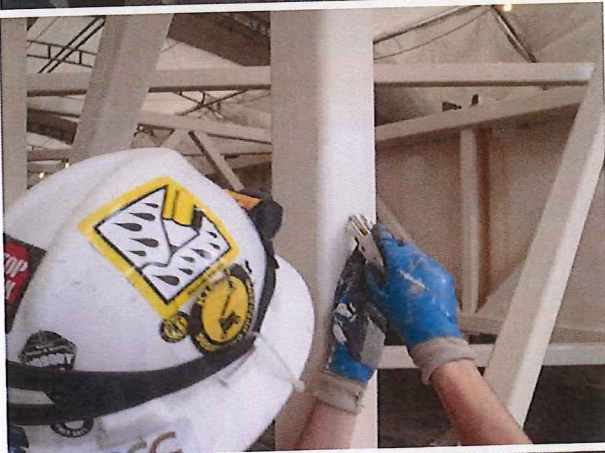
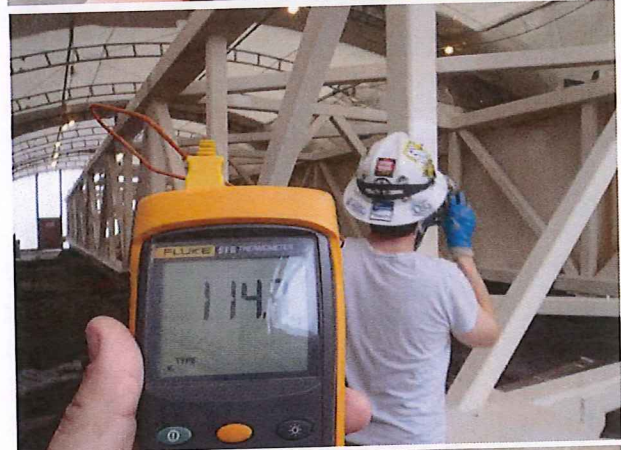
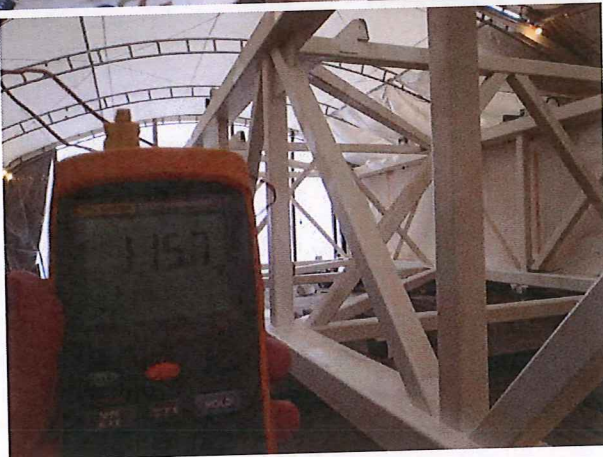
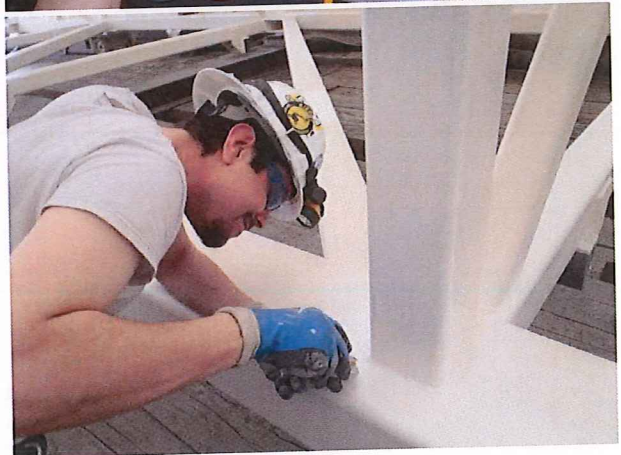
TOP SIX: Trusses 2/3 pencil hardness testing, T2/3 tent temperature readings

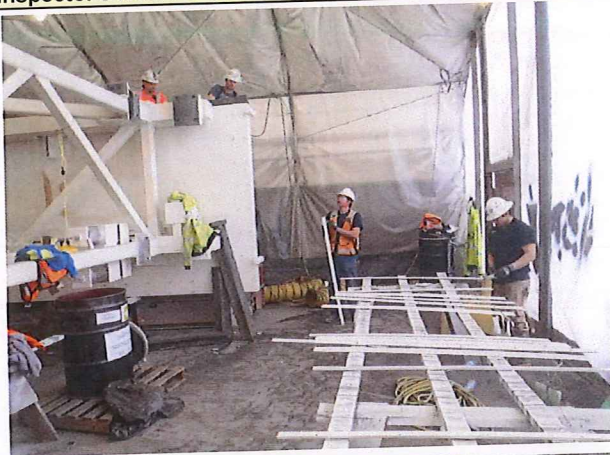
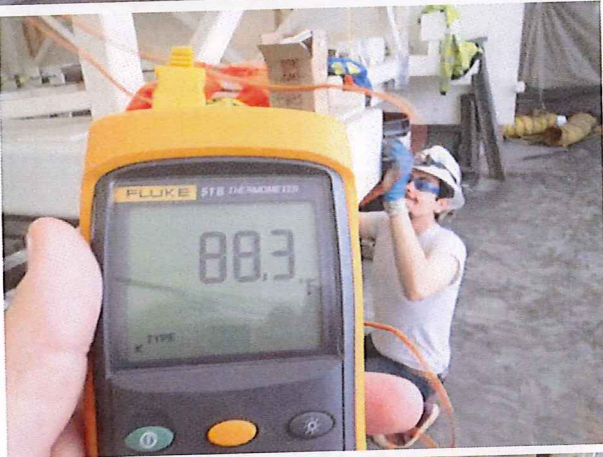
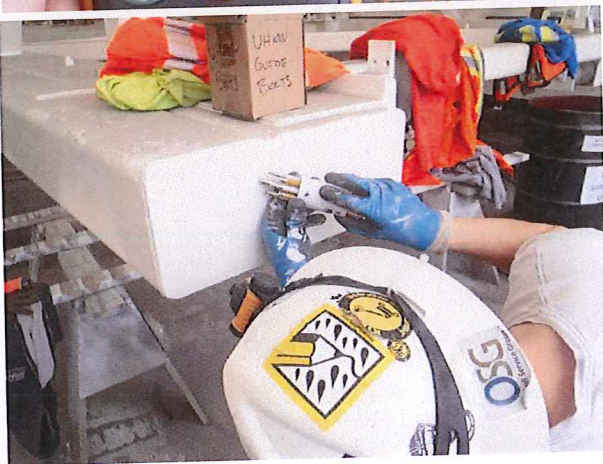
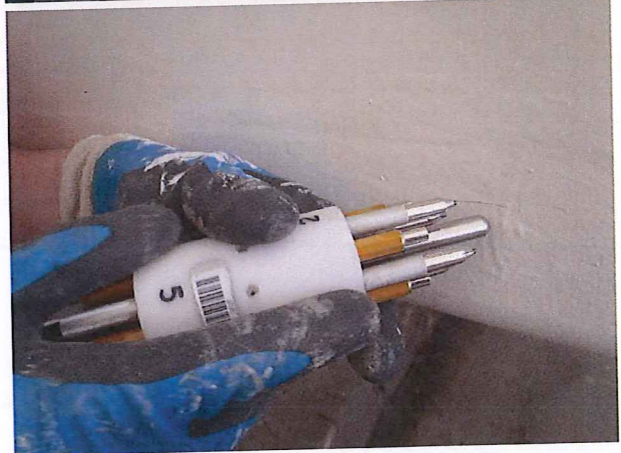
TOP SIX: Trusses 2/3 pencil hardness testing, T2/3 tent temperature readings

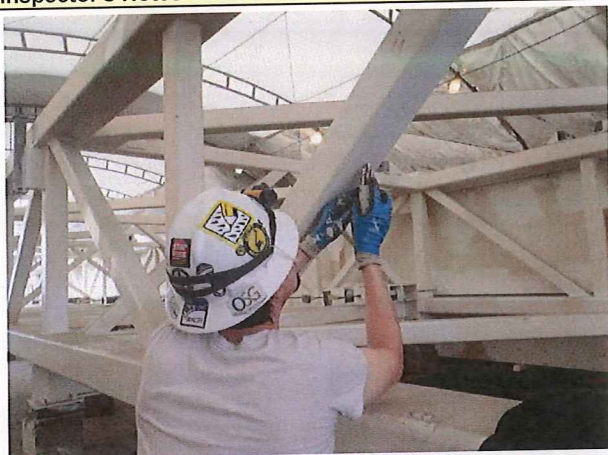
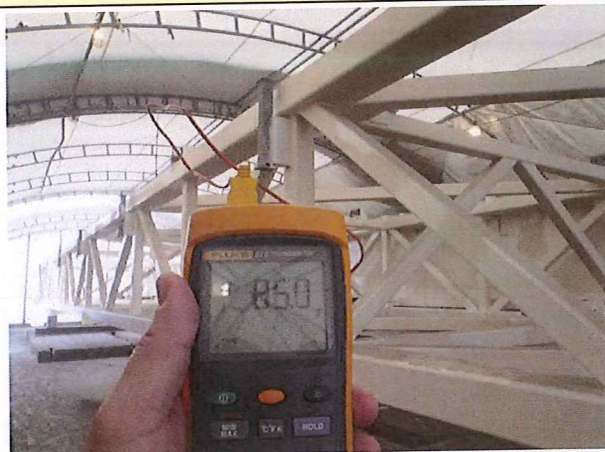
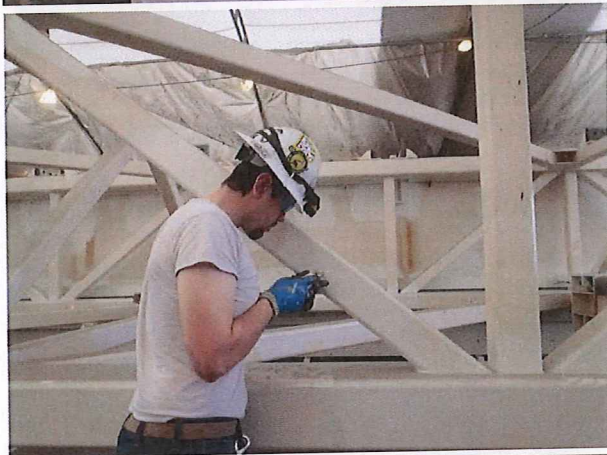
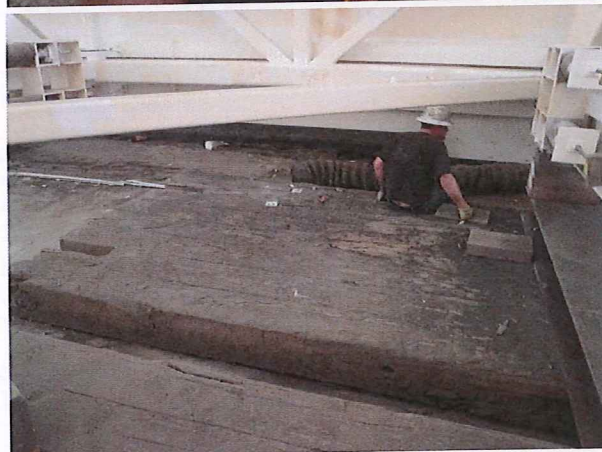
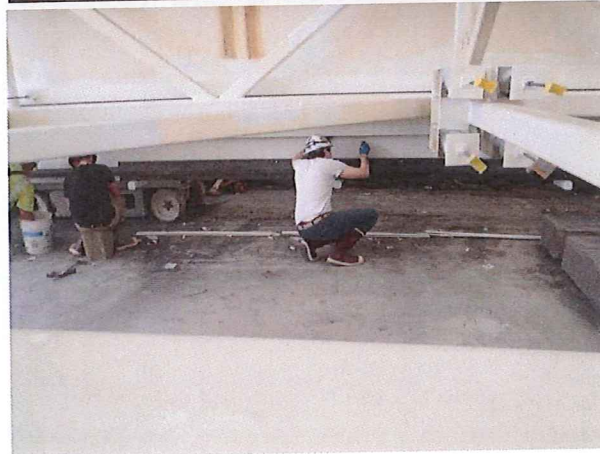
TOP SIX: Trusses 2/3 pencil hardness testing, T2/3 tent temperature readings

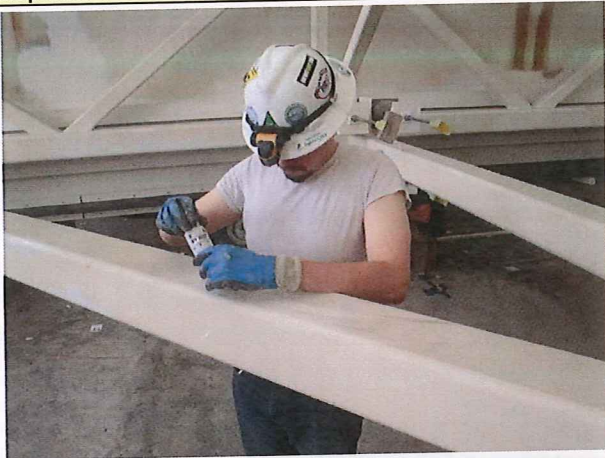
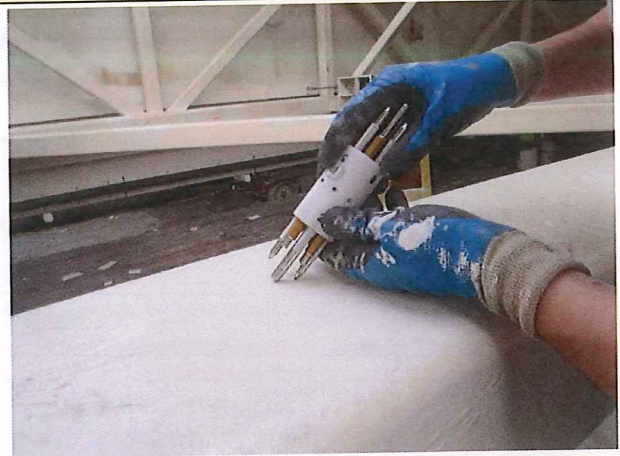
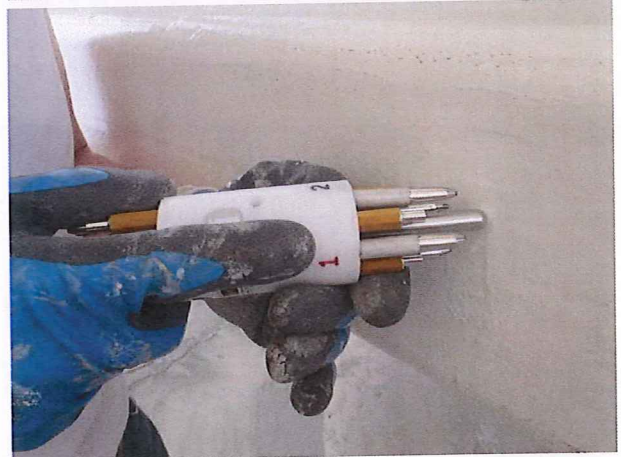
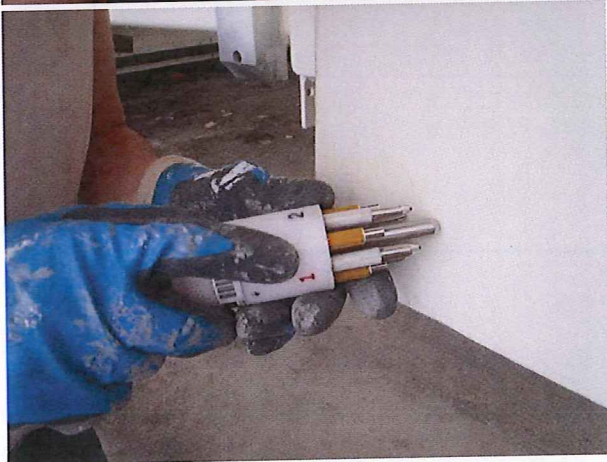
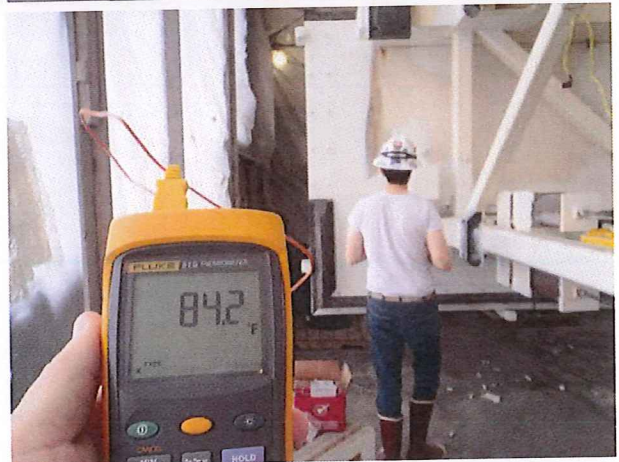
TOP SIX: Trusses 2/3 pencil hardness testing, T2/3 tent temperature readings

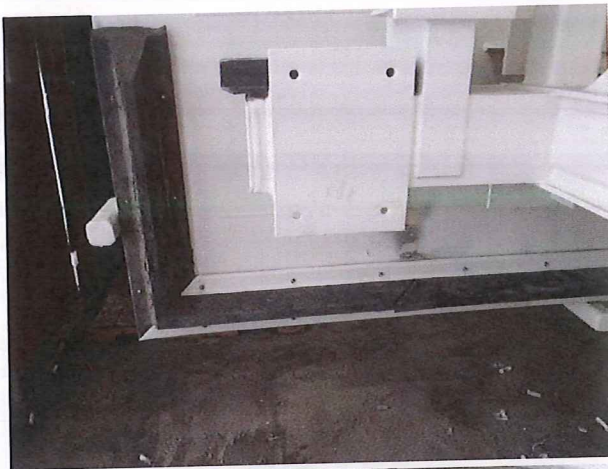
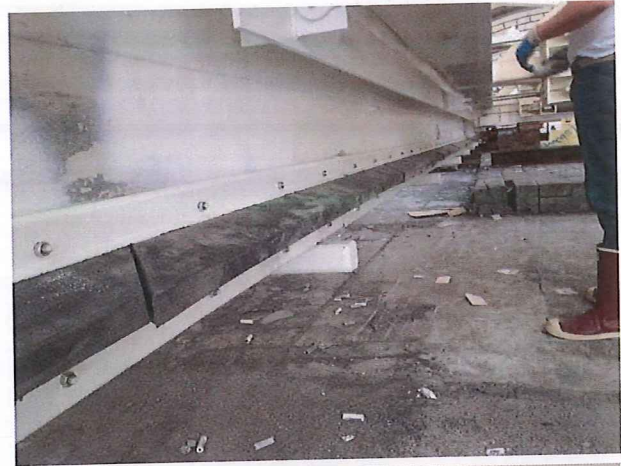
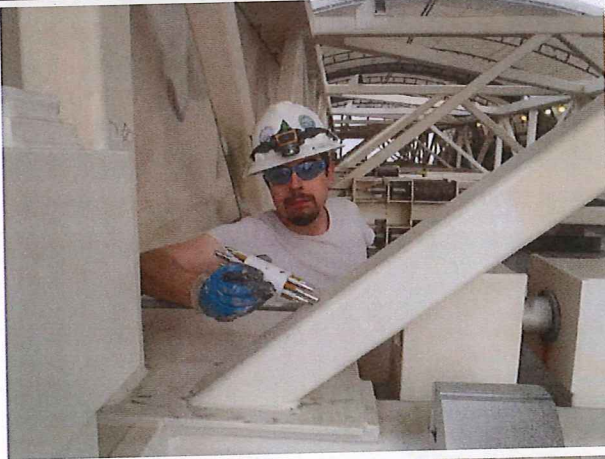
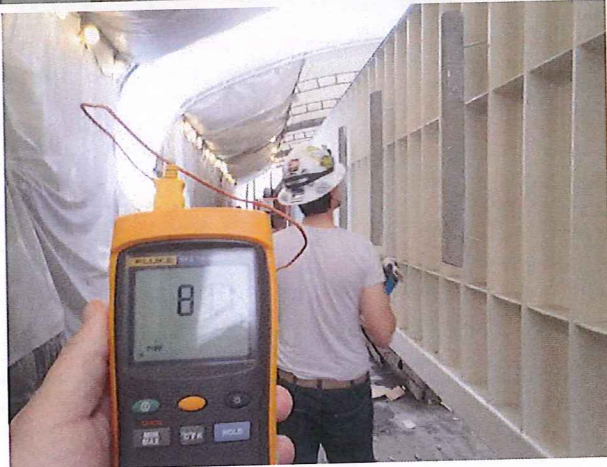
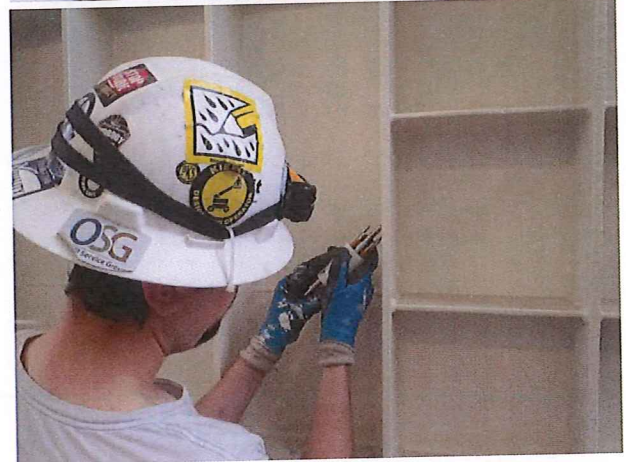
TOP SIX: Truss 1 pencil hardness testing, T1 tent temperature readings

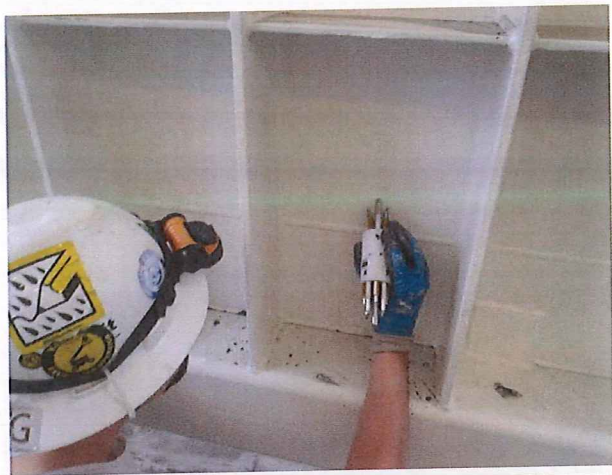
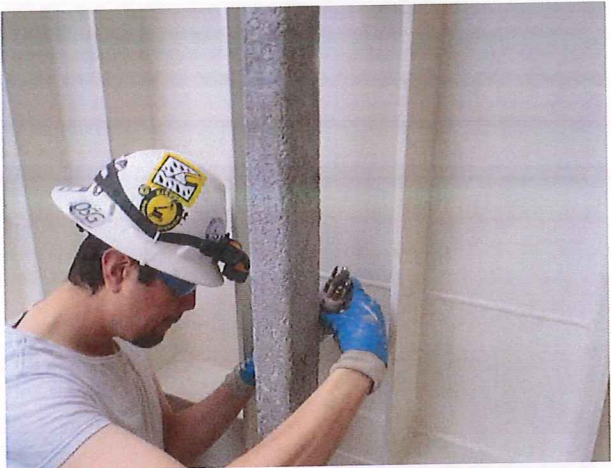
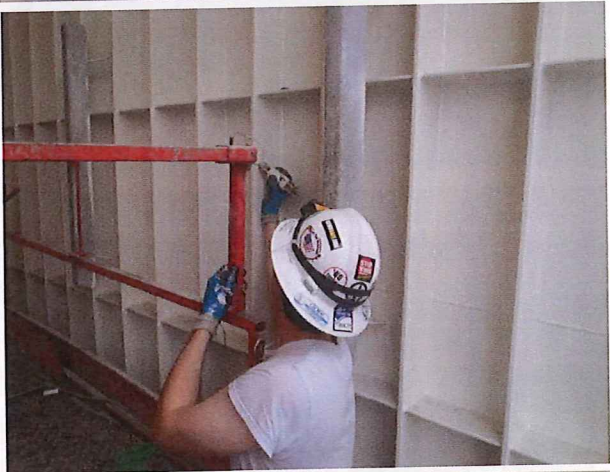
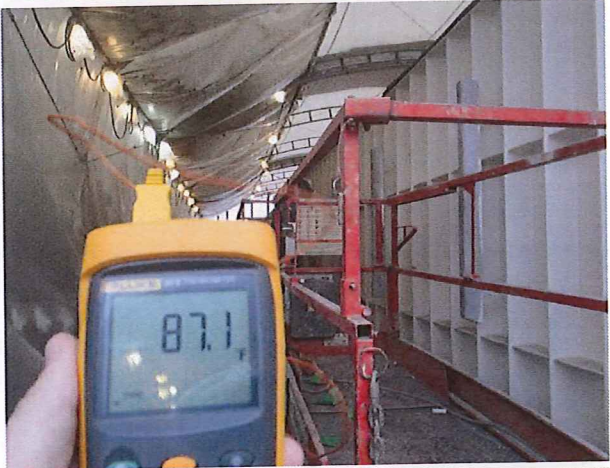
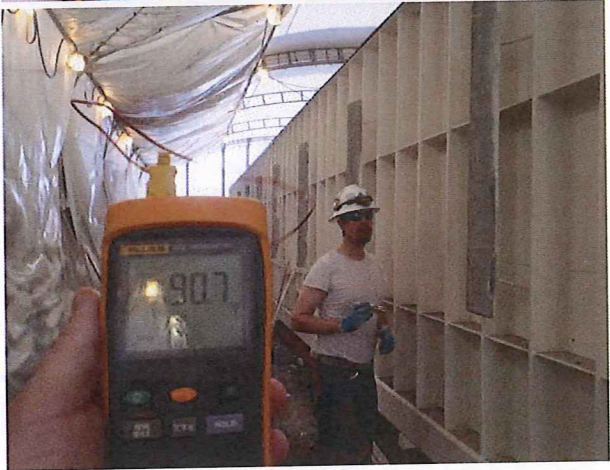
TOP SIX: Truss 1 pencil hardness testing, T1 tent temperature readings

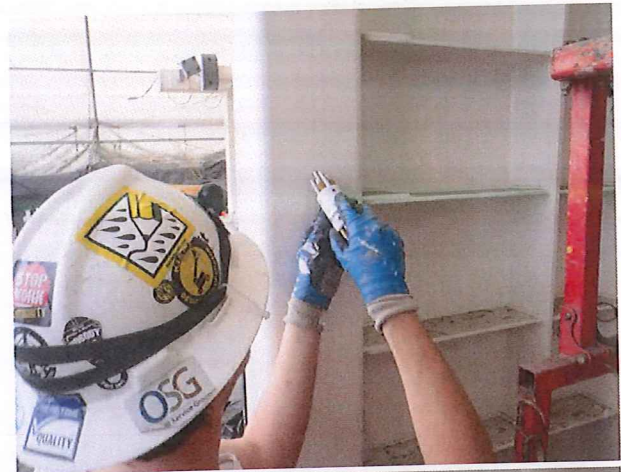
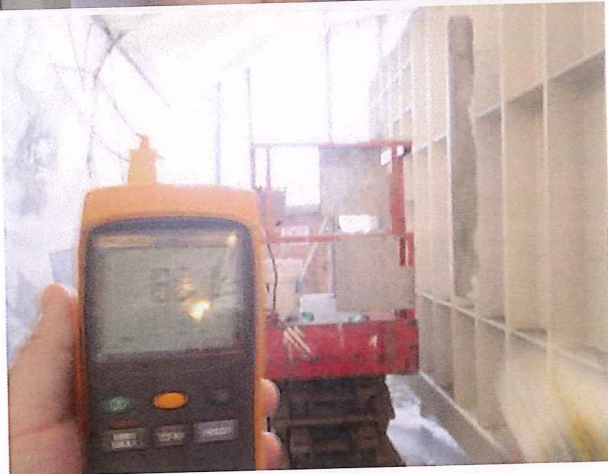
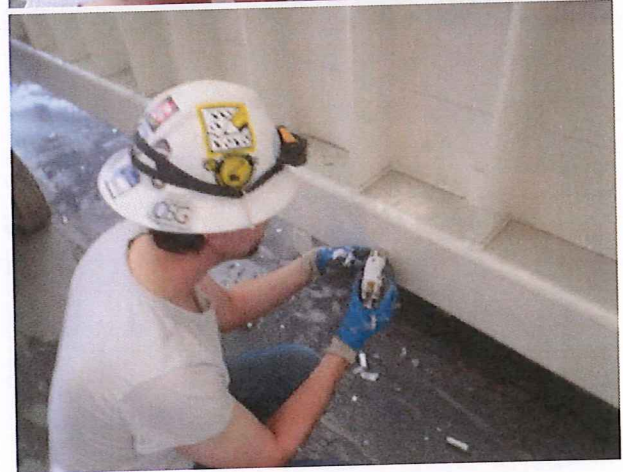
TOP FOUR: Truss 1 pencil hardness testing, temperature readings

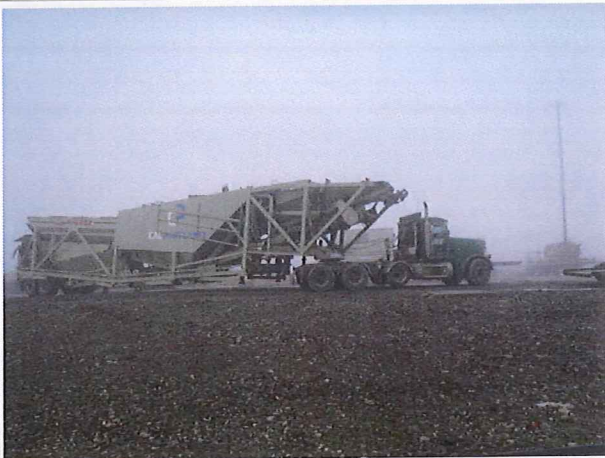
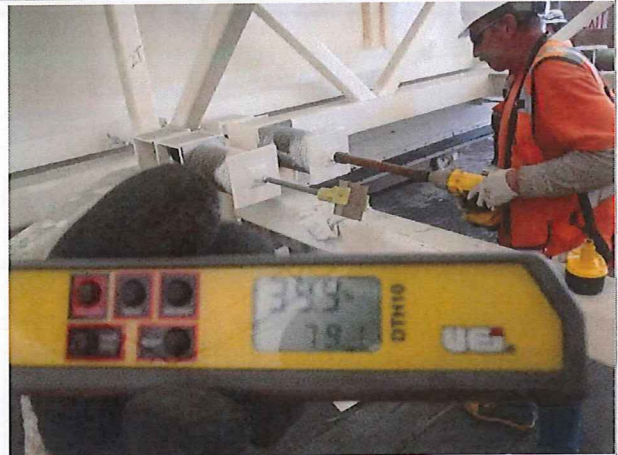
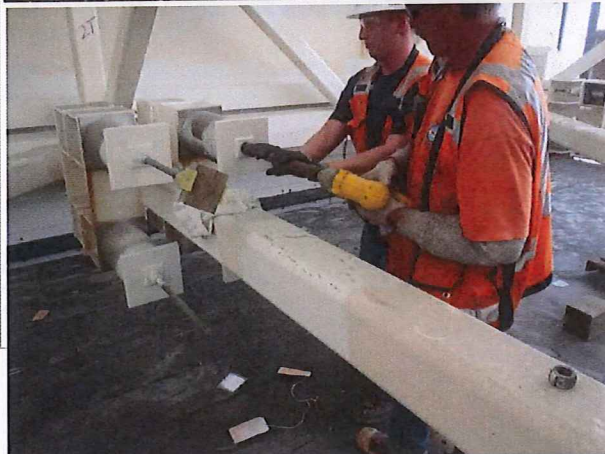
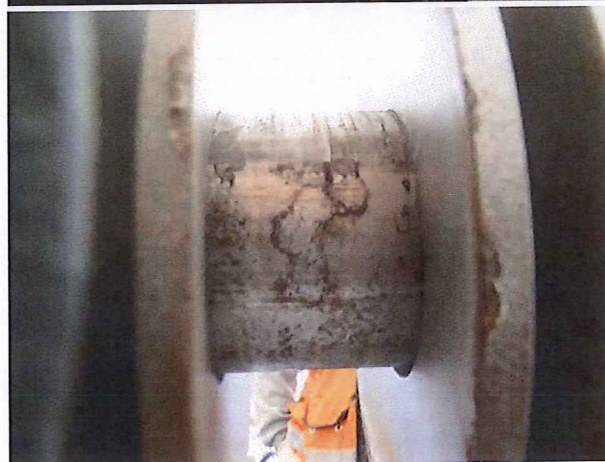
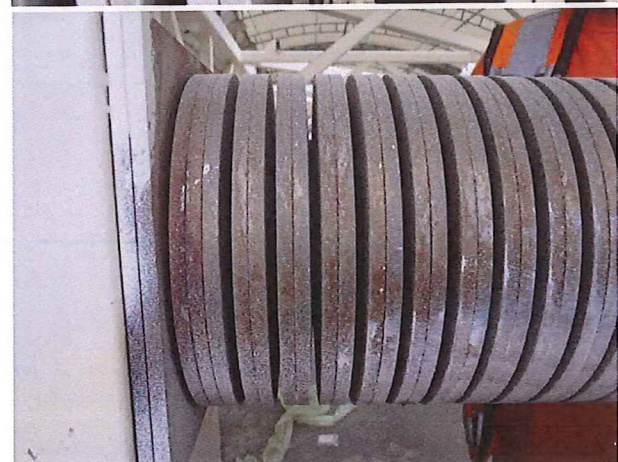
K-G QC also disassembled Belleville springs by removing stopping plate and examining disks and central guideshaft for inspection. Upper springs on lines 2 and 9 (per KPFF G04) examined per maintenance specifications within O&M manual. Spring on line 9 was disassembled due to one of the disks facing the wrong way (three disks of the same deflection stacked together). All springs appeared to be in good condition.

TOP SIX: Removal of batch plant, inspection of Belleville springs

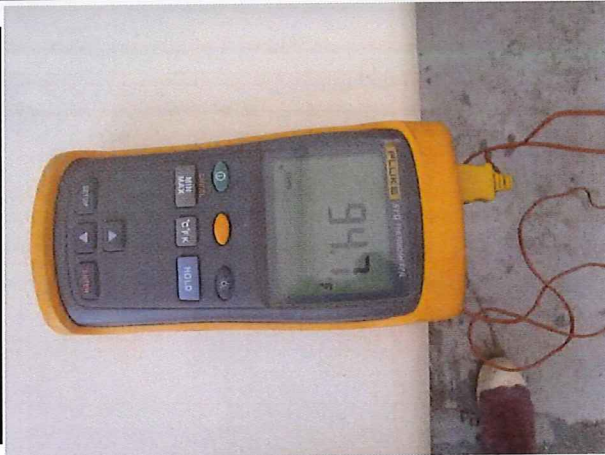
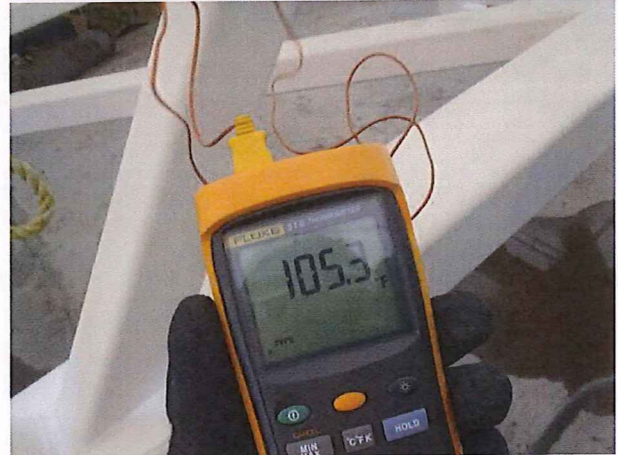
TOP SIX: T1/T2/3 tent temperature readings

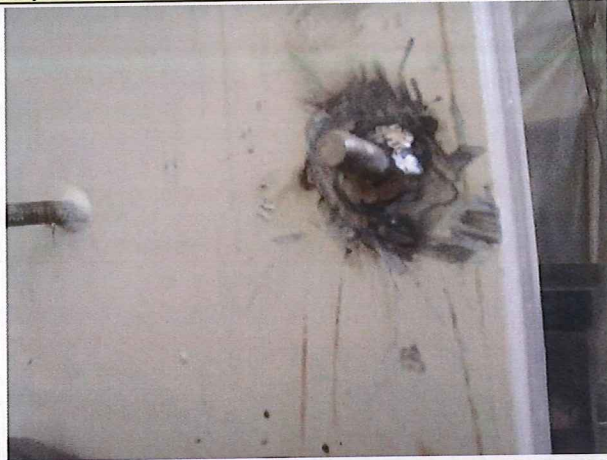
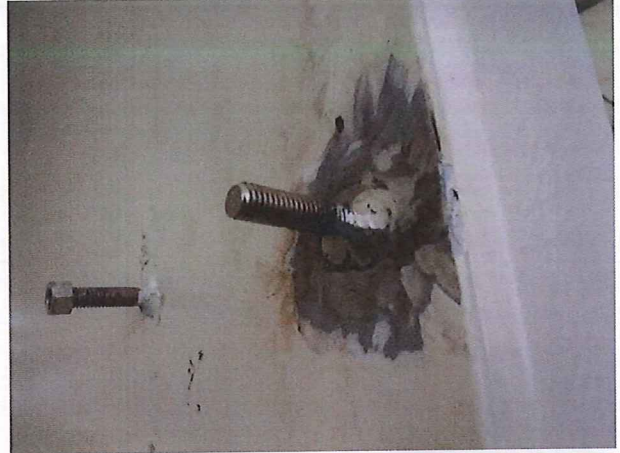
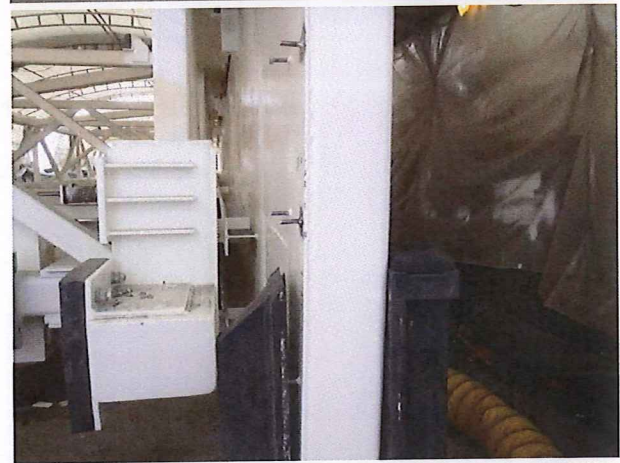
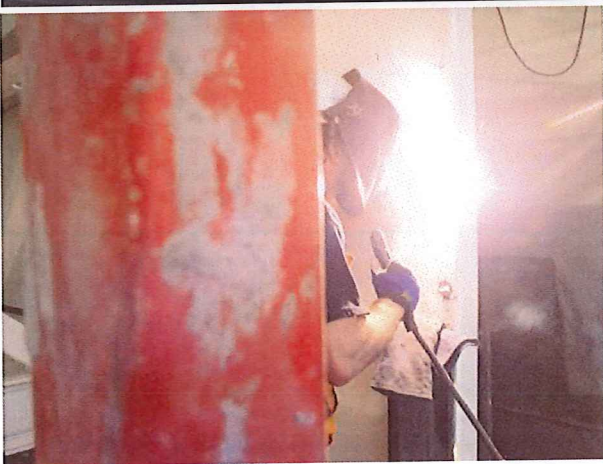
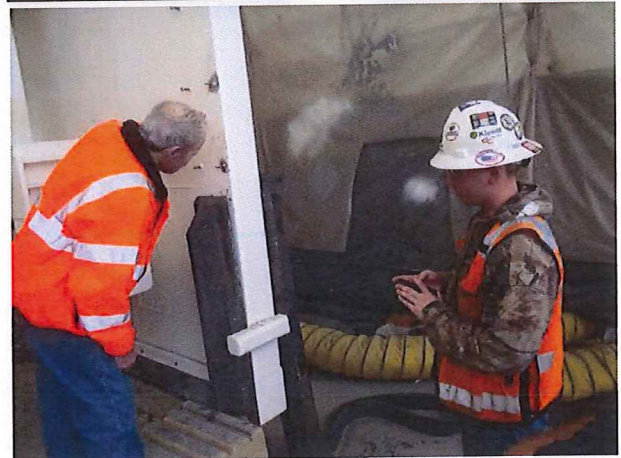
TOP SIX: Truss 1 stud repairs, welding stainless steel studs and weld inspection

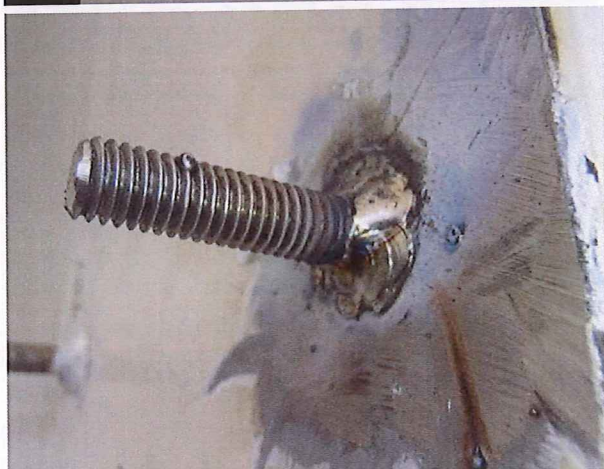
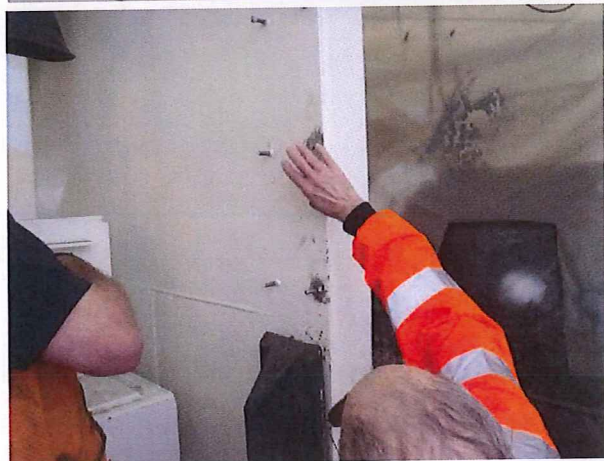
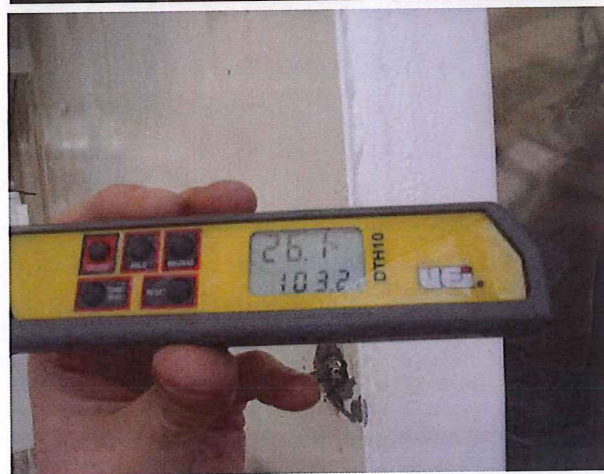
TOP SIX: Truss 1 stud repairs, welding stainless steel studs and weld inspection

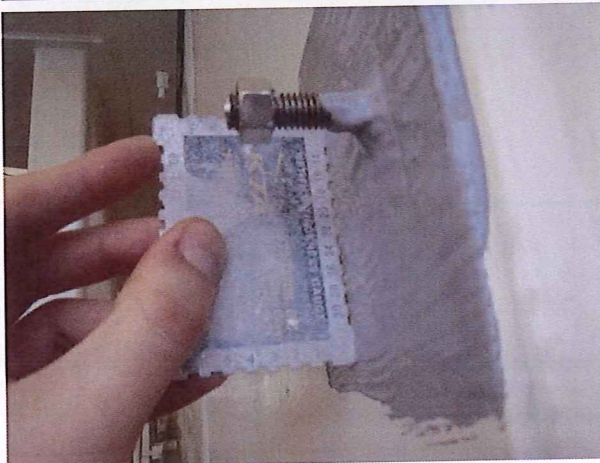
TOP SIX: Truss 1 stud repairs, coating atmosphere, Fast Clad, anchor profile, wet film thickness

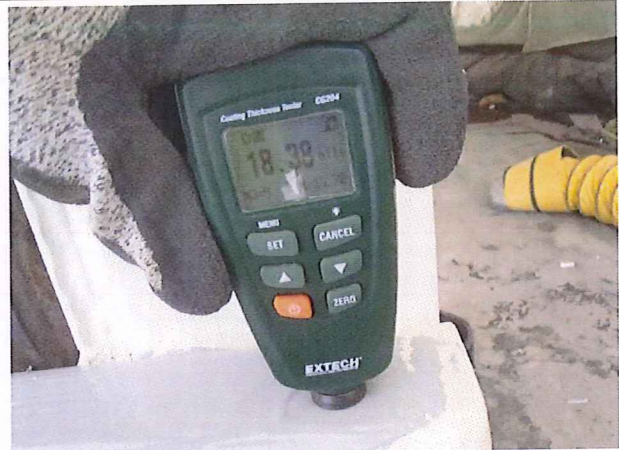
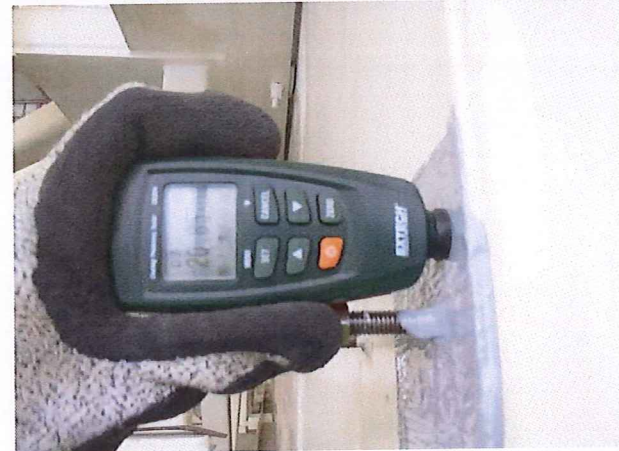
TOP FOUR: Truss 1 stud repairs, coating atmosphere, DFT readings

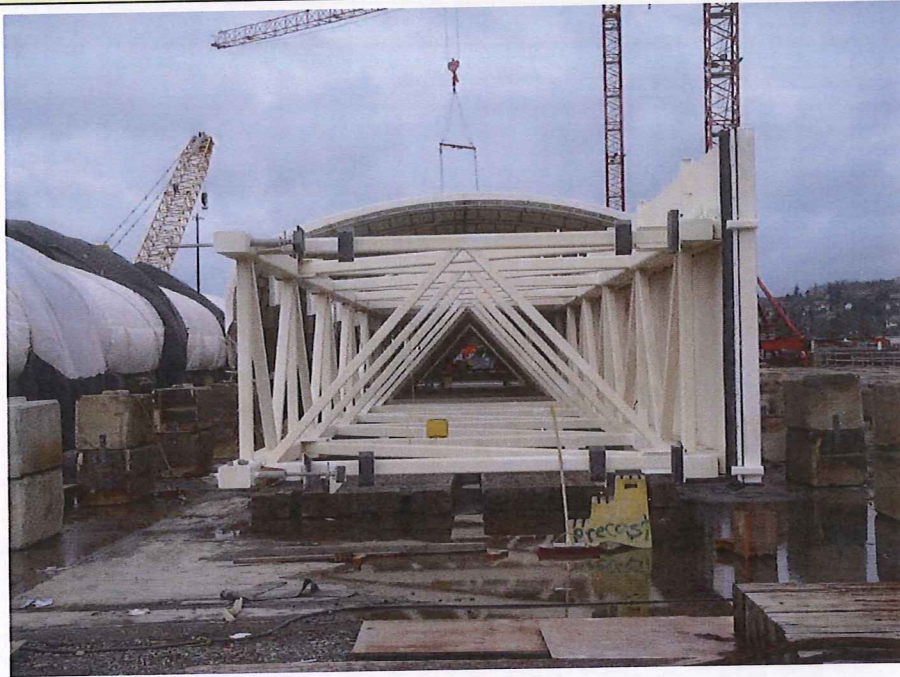
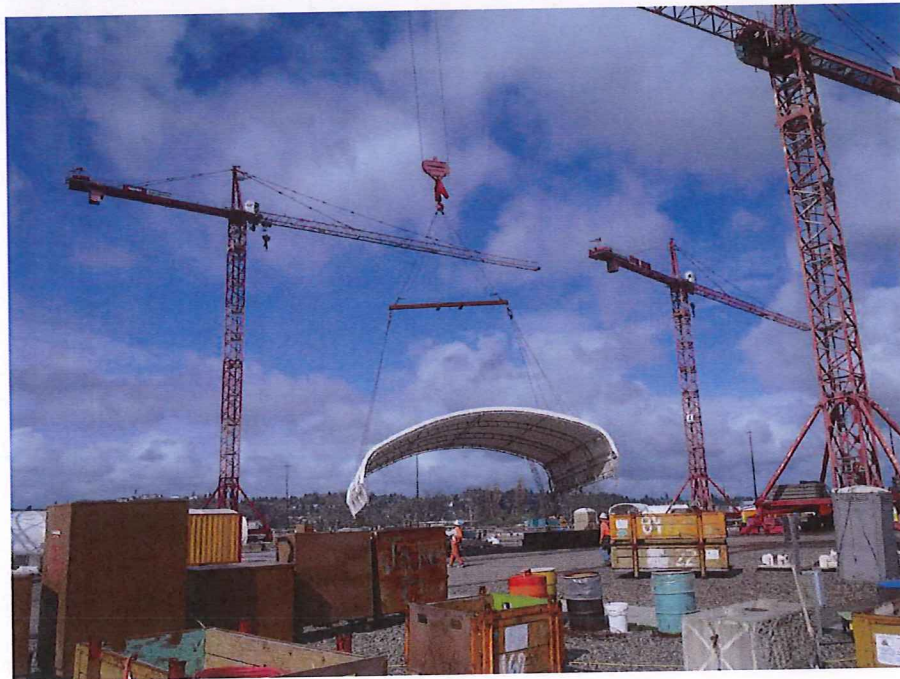
TOP TWO: Trusses 2/3 and truss 1 main tent removal, 3PM

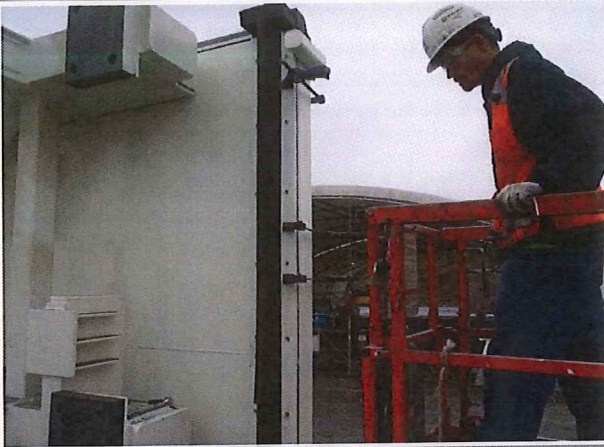
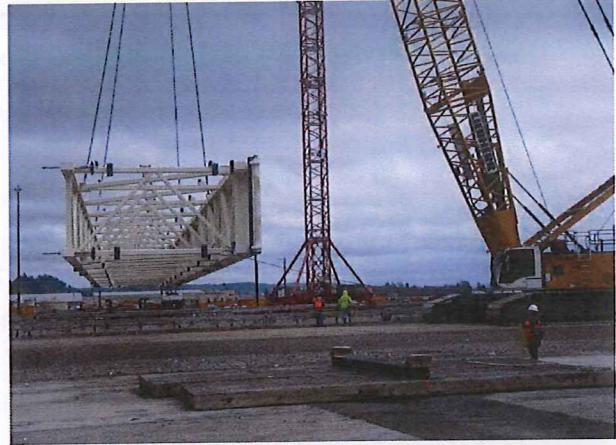
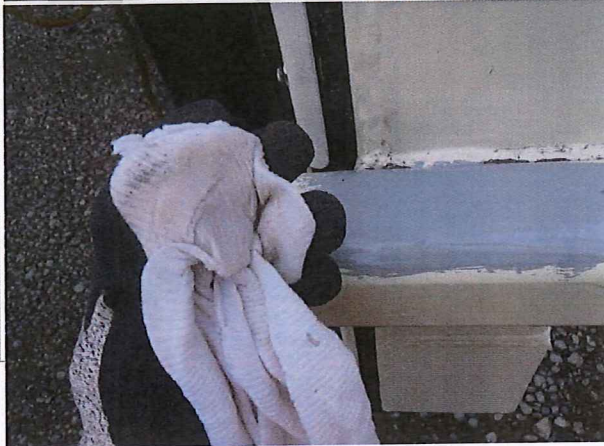
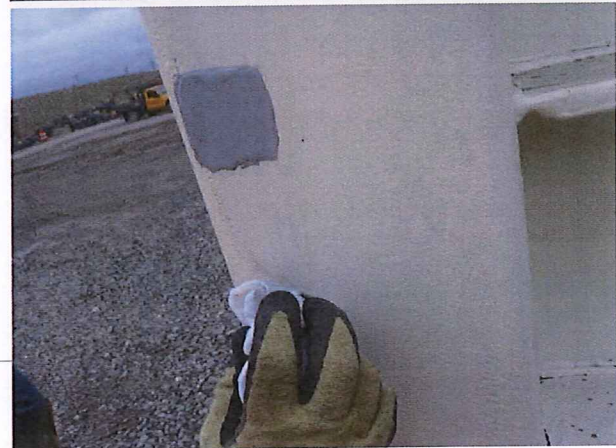
The undersigned was present with K-G QC and QV representative present to preform ASTM 54022-93 (1999), assessing the solvent resistance of organic coatings using solvent rub, as per data sheet requirements for Fast Clad ER Epoxy, upon truss 1 repairs of broken studs repaired upon 3/28/15. DFT first preformed on test area, and found to be 20.2 mils. Per Sherwin Williams, clean dry cloth saturated 100% in MEK solvent, rubbed 50 times with moderate hand pressure; DFT tested afterwards and found to be 20.2 mils. Testing preformed 48 hours of initial application.

TOP FOUR: Solvent wipe test upon Fast Clad, truss relocation

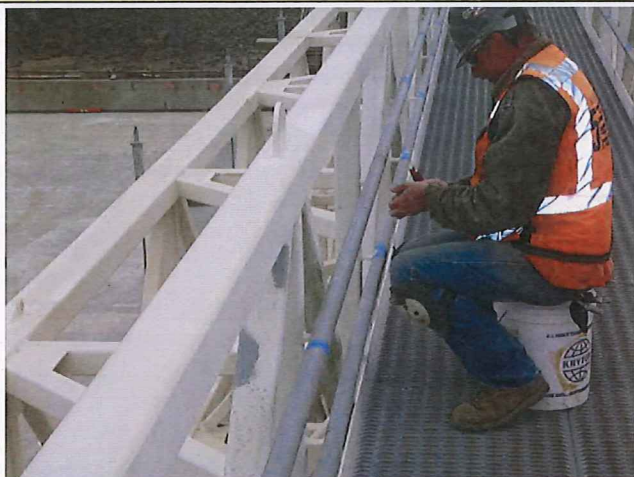
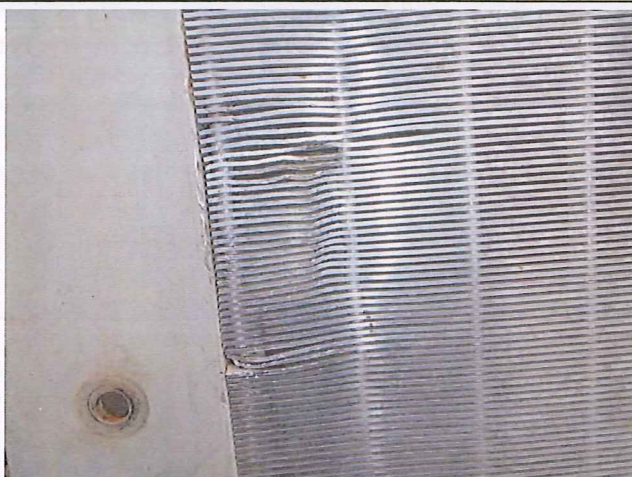
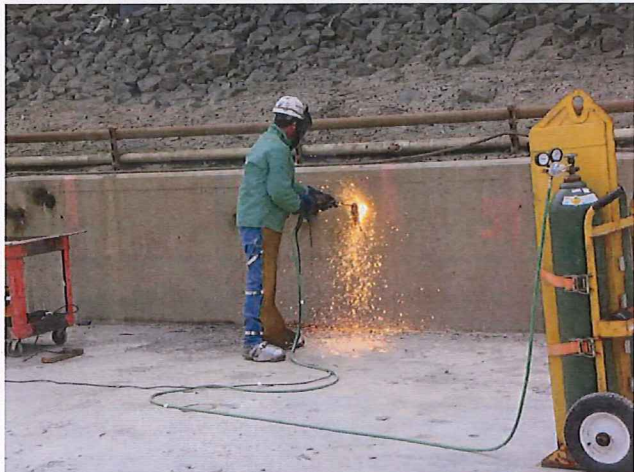
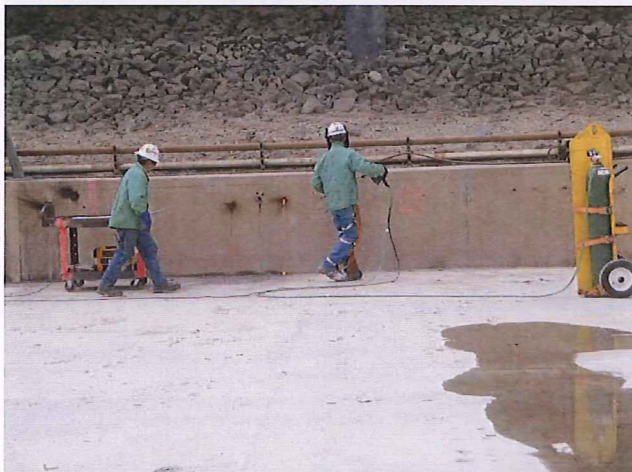
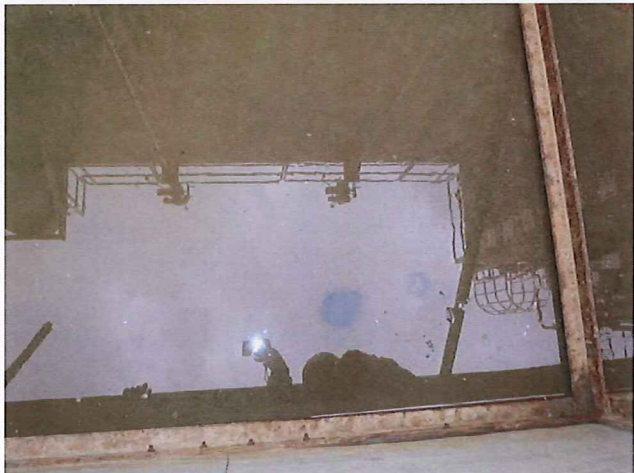
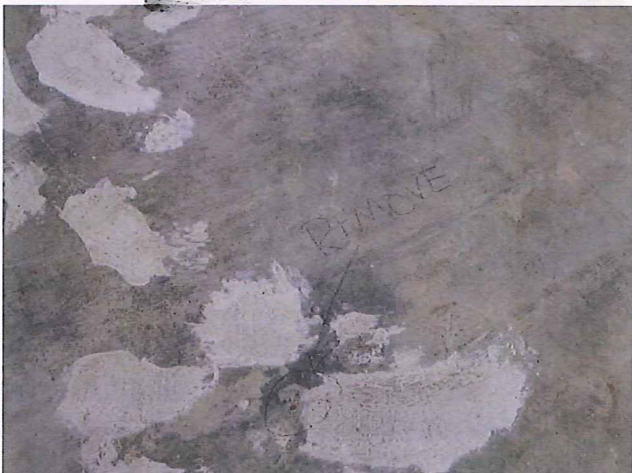
**TOP SIX:** Handrail coating repairs, dented fishgrate on HCS box (PLI #149), oxy-lance removal of shi-bolt holes and typical repairs remianing for Southern portion of casting basin slab
